Summary of the “Report on the Review Meeting for Fire Prevention Measures and Approach to Firefighting Operations after the Warehouse Fire in Miyoshi Town, Saitama Prefecture” (Part One)

Kensuke Kimura, Fire Prevention Division, FDMA

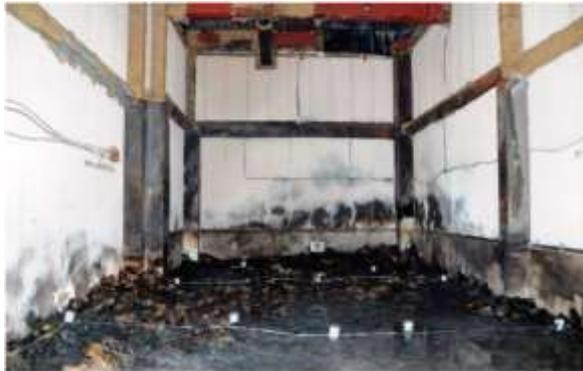
Conditions inside the scrap material room

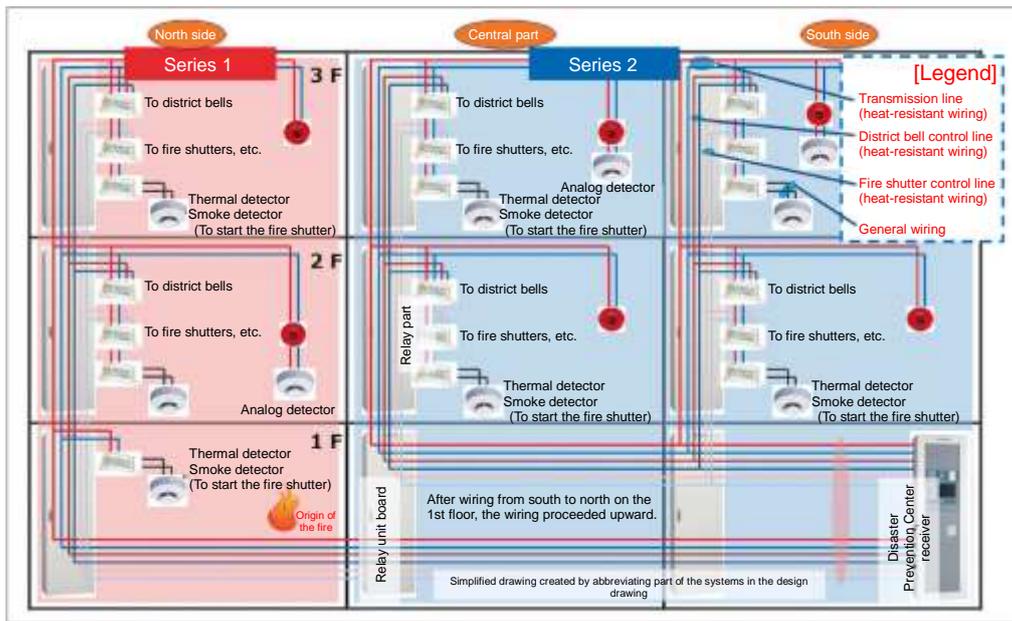
Also, within the receiver, the blowing of the fuse which formed part of the wiring for the fire shutters was time-stamped at 11:23.

Wiring of receivers

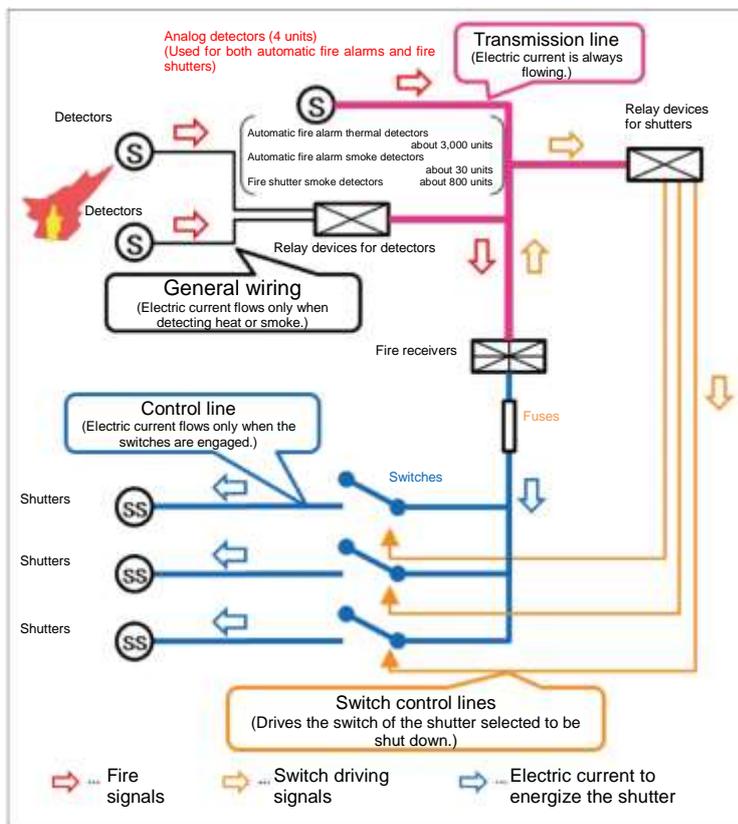
While there are about 3,000 thermal detectors and about 30 smoke detectors installed for the automatic fire alarm system along with about 800 smoke detectors for the fire shutters, all of these detectors cause electric current to flow when heat or smoke is detected. Current also flows to a relay device in such event as a short circuit. For this reason, the wiring is done using general wiring with no heat-resistant capability. On the other hand, in the fire-proof compartments of the floor-penetrating parts in parts of the conveyors, 4 analog type detectors are installed, which transmit information on the percentage of smoke as necessary. Since these detectors are always driving the current, they are wired using transmission cable integrating the fire receivers, the relay devices for the detectors and the relay devices for the fire shutters. For this reason, when a failure such as a short circuit occurs at a given location, the information of all connected detectors cannot be transmitted at all.

Outline of wiring (line diagram)

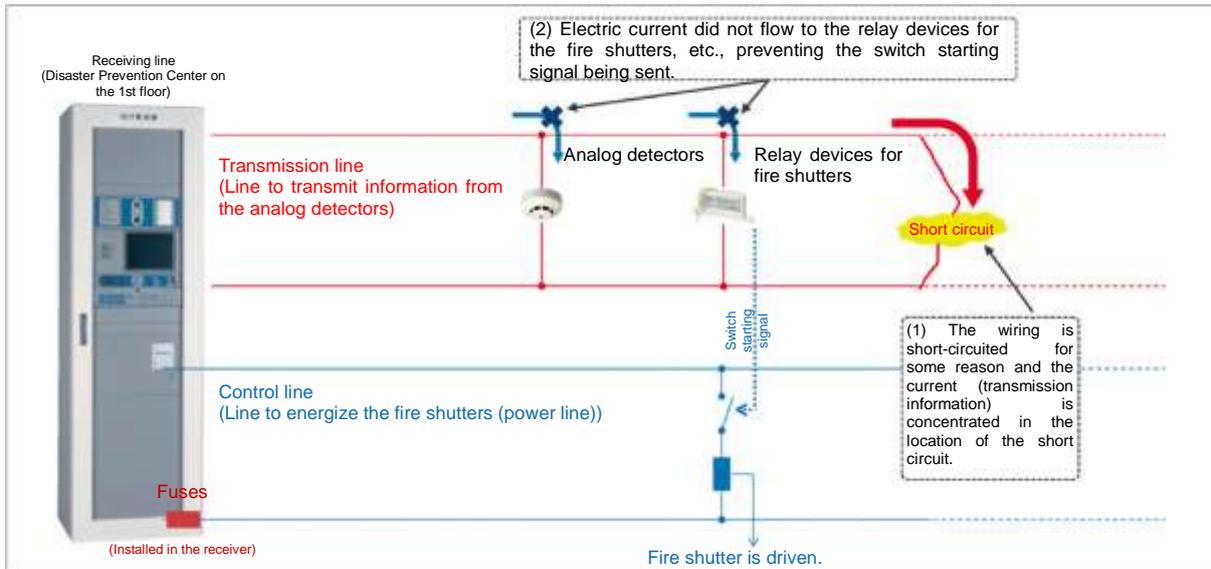
Outline of wiring (multi connection diagram)

Regarding the cause of many fire shutters in series 1 not functioning, it is considered that the wiring used for transmitting information from the detectors (including the analog detectors connected to the transmission lines) was for some reason short-circuited in the fire, losing the entire functionality of the series as a consequence, which prevented the signals from the detectors being sent to the relay devices for the fire shutters.

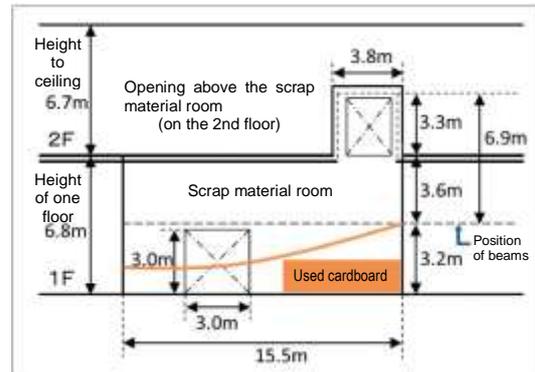
According to the statement of the person who discovered the fire, the used cardboard had accumulated to a height of about half the height of the scrap material room on that day.

Status of piled-up used cardboard in the scrap material room

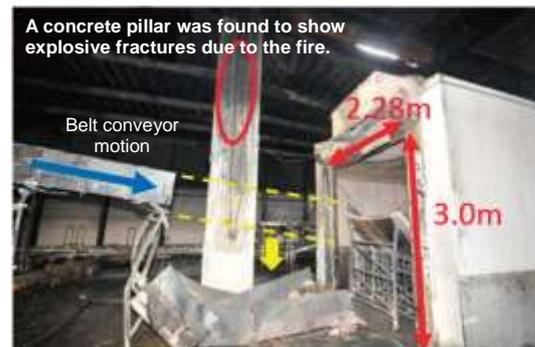
As a result, a reinforced concrete pillar on the 2nd floor near the opening was severely heated and showed explosive fractures.

Near the opening above the scrap material room (2nd floor)

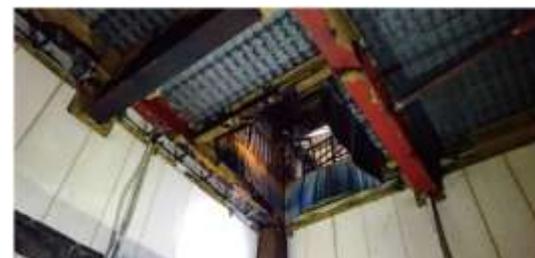
The fire in the room is considered to have flared up due to the intake air supplied from the forklift exit (the exit point for used cardboard) which caused much of the unfolded cardboard in the room to burn severely, with high temperature flames and heat bursting out from the opening above the scrap material room (2nd floor).

Opening in the ceiling of the scrap material room on the 1st floor

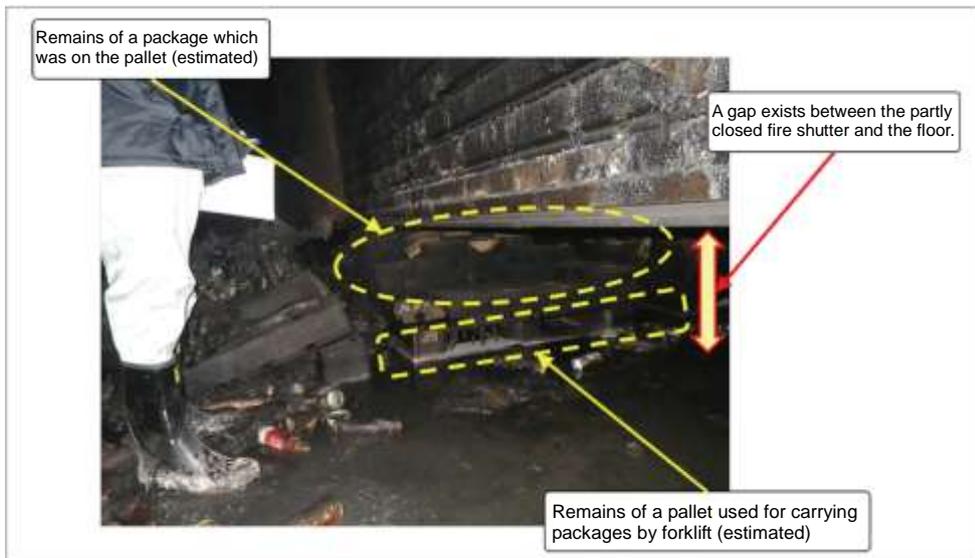
Remaining items at a location where a fire shutter was to come down

At a location where one of the fire shutters was to have come down, the on-site survey found the remains of some items considered to be packages stored at that time. It is considered that these packages and some other items stored in the warehouse left at this location where the fire shutter was to come down provided one of the causes of the closure difficulties.
