Summary of the “Report on the Review Meeting for Fire Prevention Measures and Approach to Firefighting Operations after the Warehouse Fire in Miyoshi Town, Saitama Prefecture” (Part One)

Kensuke Kimura, Fire Prevention Division, FDMA

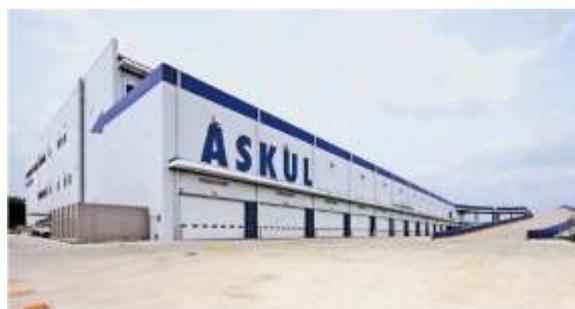
Warehouse external view

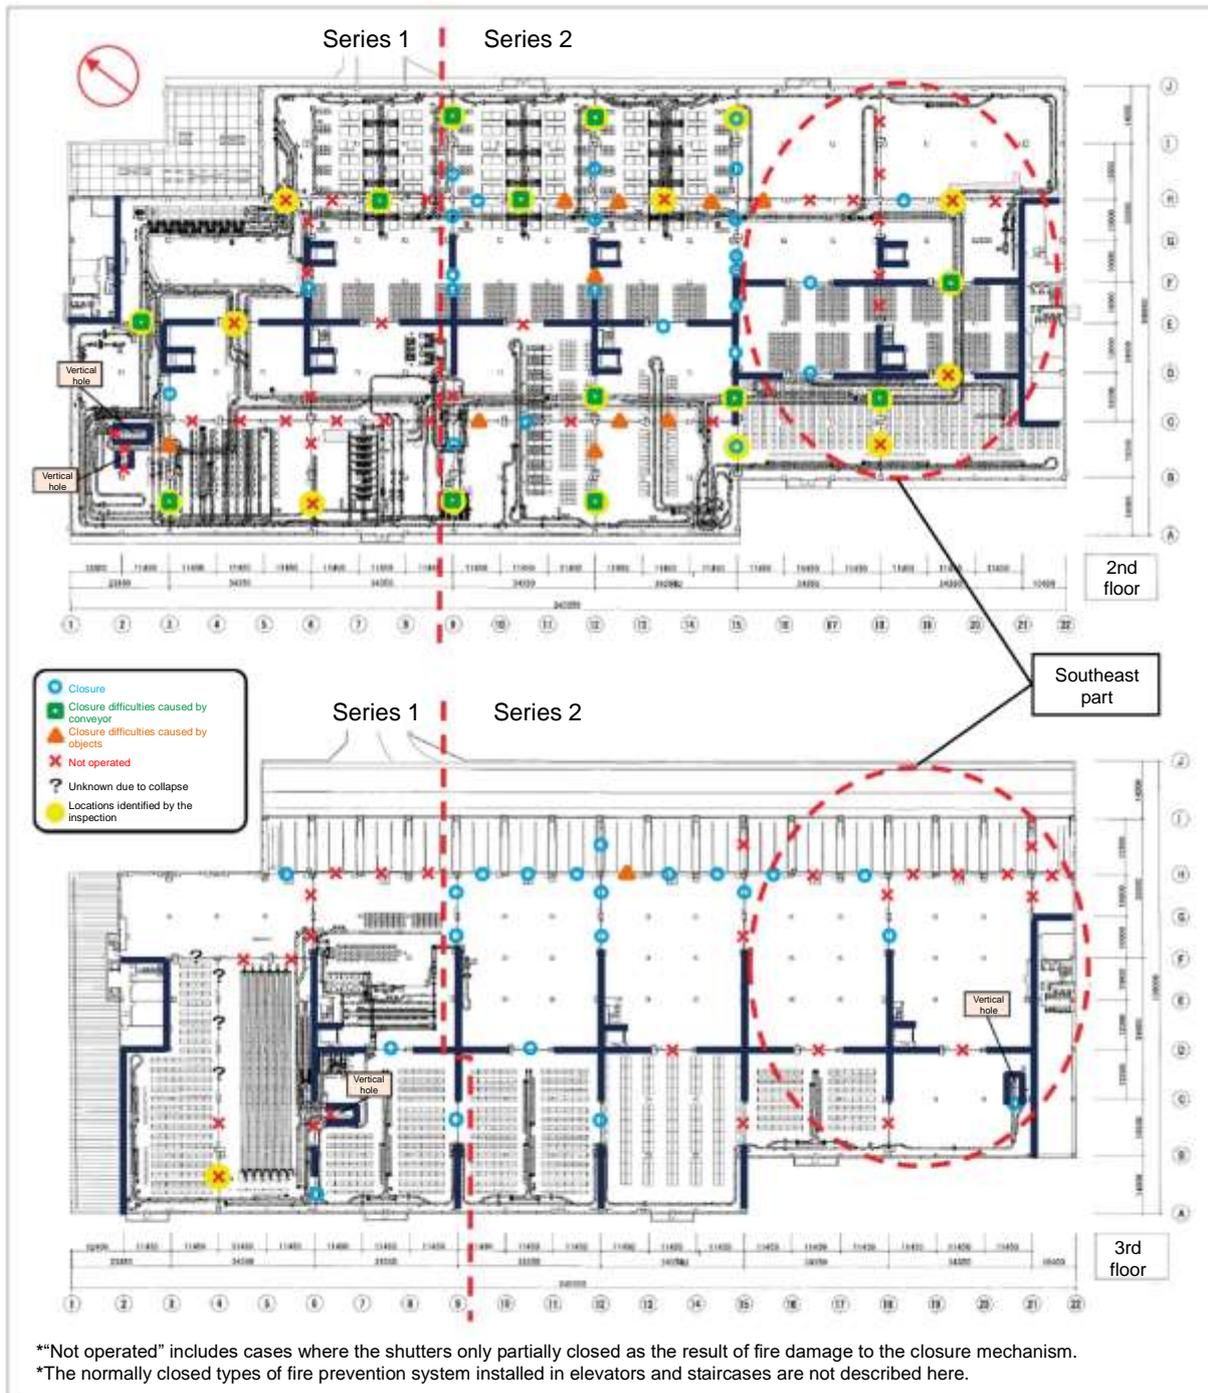
For series 1, the transmission line developed a failure at 09:17, and then the functionality of the transmission line became unstable and was lost at 09:21, causing the inability to transmit signals from the detectors to the fire shutter relay devices, thereafter disabling the fire shutters.

In this building, 4 units of analog type detectors (all installed at vertical hole portions), and the analog detectors installed at the upper location of the scrap material room (2nd floor) are considered to have impacted the failure of series 1.

Also, within the receiver, the blowing of the fuse which formed part of the wiring for the fire shutters was time-stamped at 11:23.

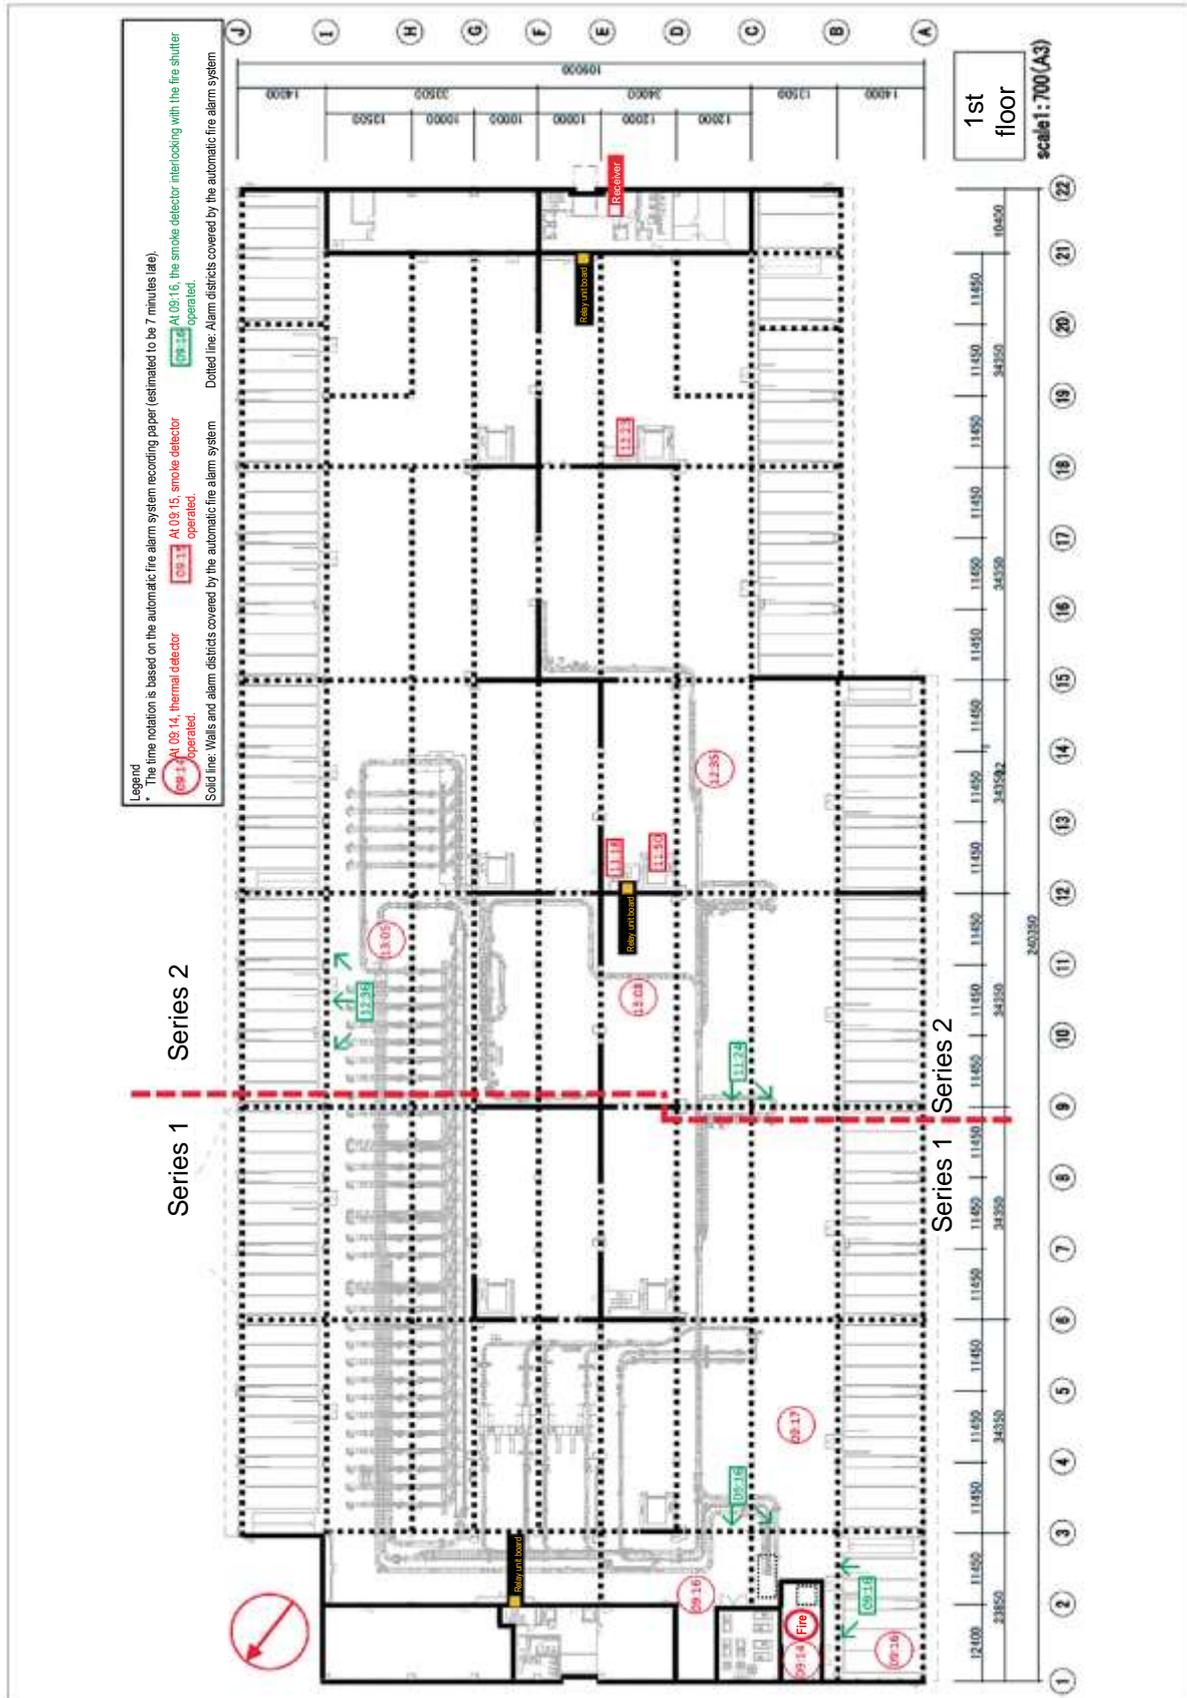
The fire was recognized at 09:14 when the thermal detector in the alarm district of the scrap material room situated at the northwest corner of the 1st floor detected the fire.

Top view of the warehouse (1st floor)

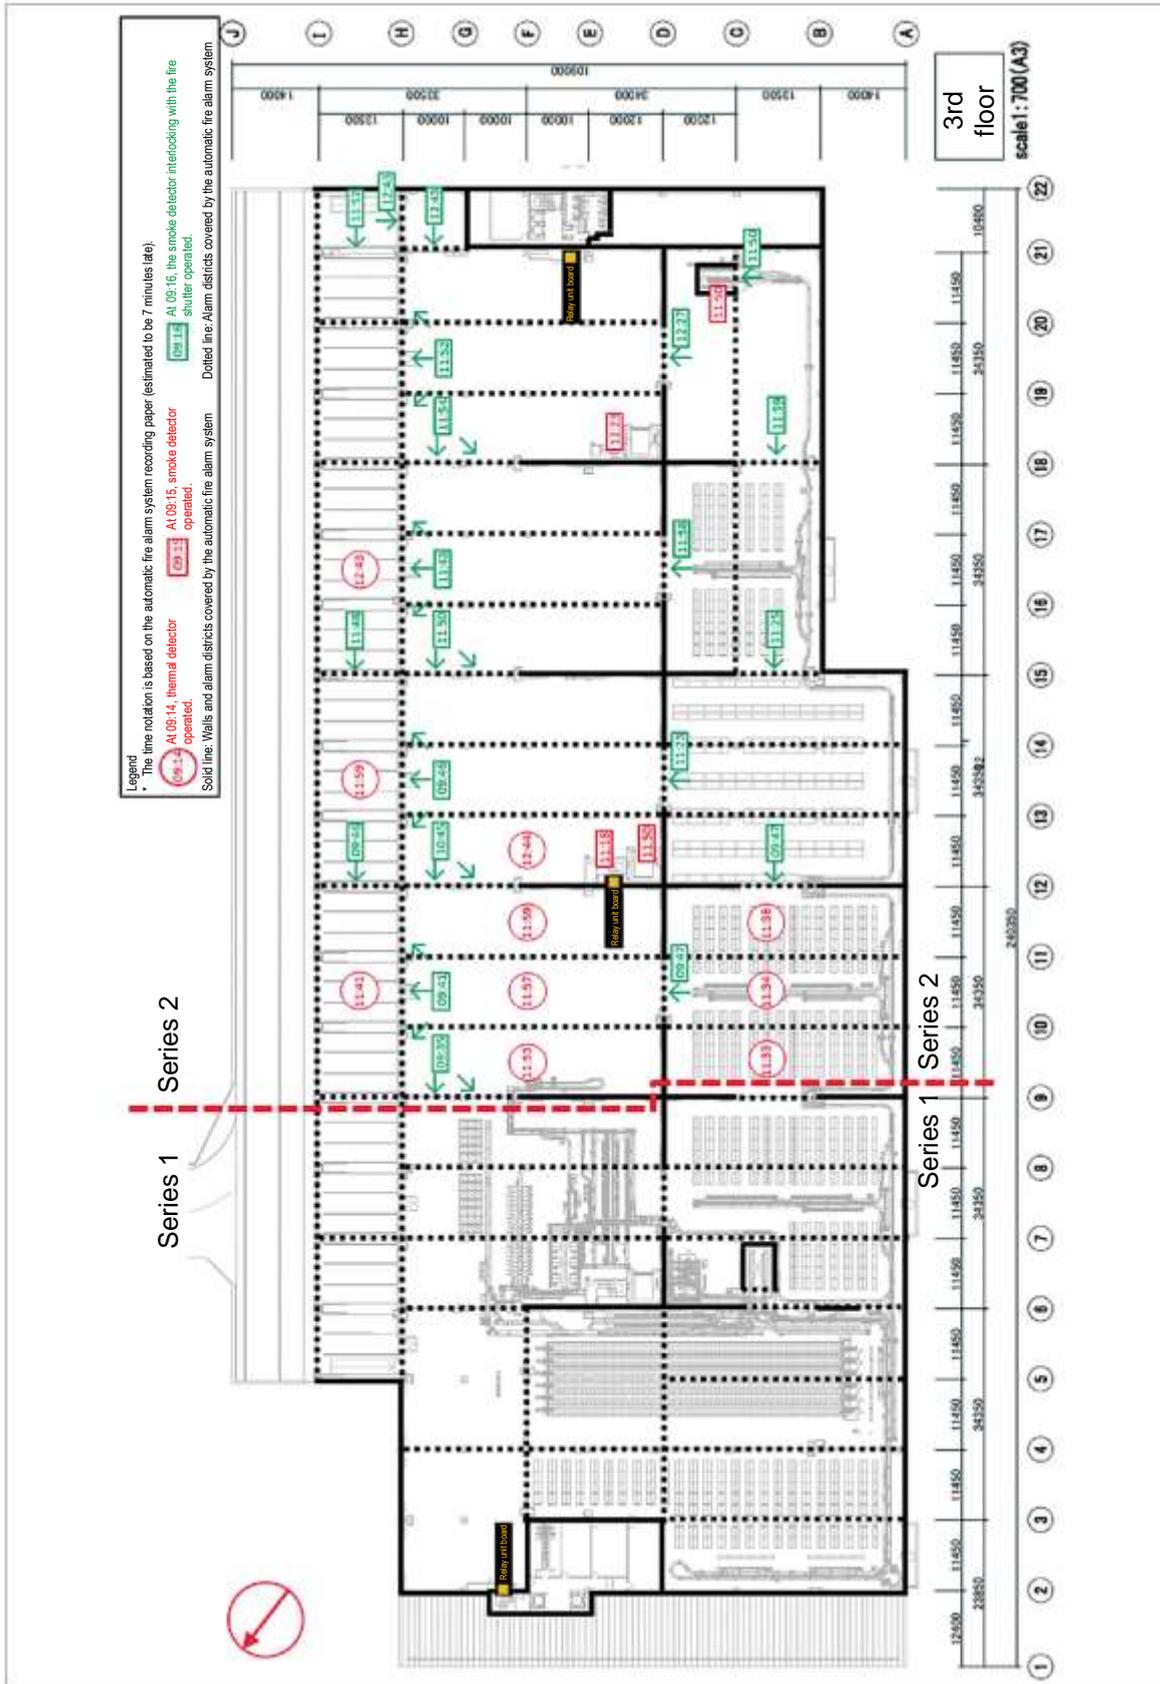
Top view of the warehouse (3rd floor)

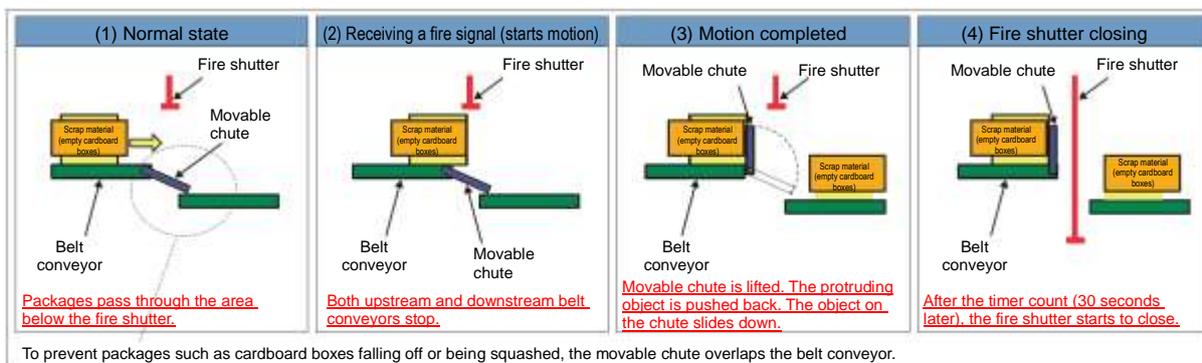
- They are used solely for "scrap material" such as empty cardboard boxes and cardboard offcuts.
- They are mainly installed in high positions. (3.0 m maximum and 1.5 m at the locations where workers would throw down the scrap material)
- If there is a gap between the conveyors, it is possible that any scrap material falling off the conveyors during transportation could cause closure difficulties for the fire shutters.
- The movable chutes which prevent the scrap material falling off are designed to overlap the downstream belt conveyor (the chutes are free to move upward), hence the movable chutes have a way to flip upward to get out of the way of the fire shutter.
- Since they use commercial power and do not have any backup power, they do not work during a power outage.
- They use general wiring and have no heat resistance.

Outline of the belt conveyor

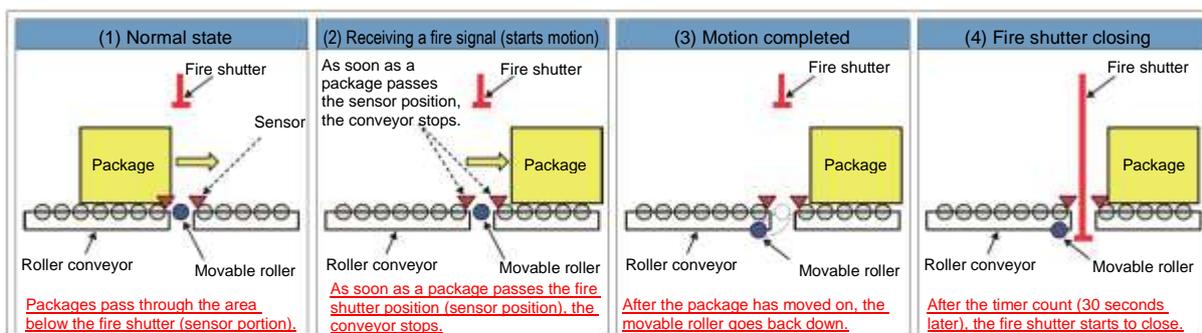
Outline of the roller conveyor
