## Summary of the “Report on the Review Meeting for Fire Prevention Measures and Approach to Firefighting Operations after the Warehouse Fire in Miyoshi Town, Saitama Prefecture” (Part Two)

Kouta Isaki, Fire Prevention Division, FDMA

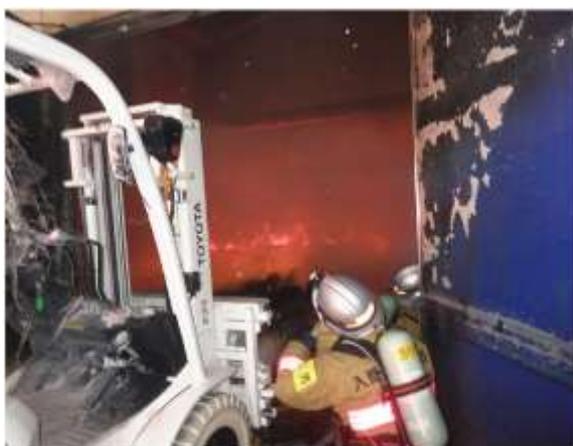
Status inside the scrap material room

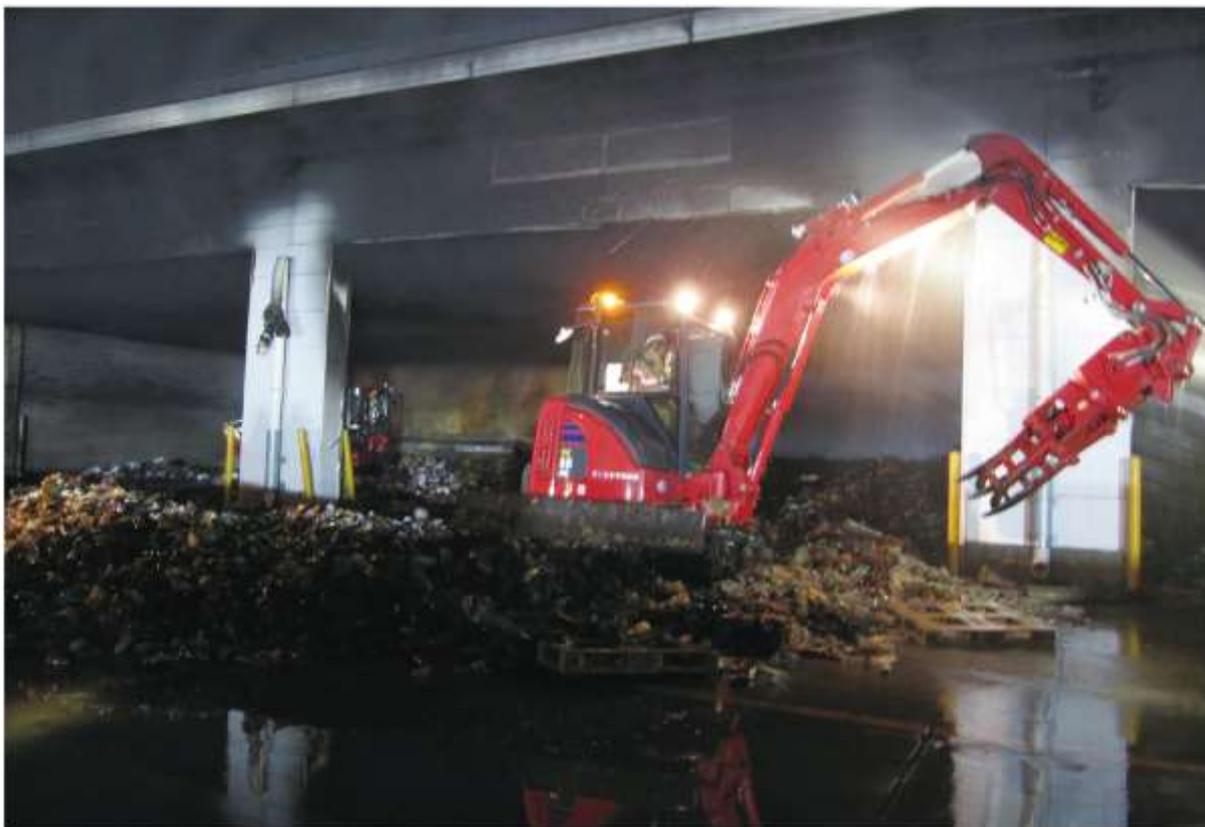
Activity status of removing firefighting obstacles

Although the initial demolition of external walls was conducted by firefighting squads using their own engine cutters, which took a long time to create the openings, we requested the use of heavy machinery owned by private companies to conduct the large-scale demolition of the outer walls from the second day.

Although the demolition of the walls using private heavy machinery also required consideration of the fire status inside the building and the building structure itself as well as the additional problems of securing operators, the openings thus created were effective for both injecting water and exhausting smoke and heat.

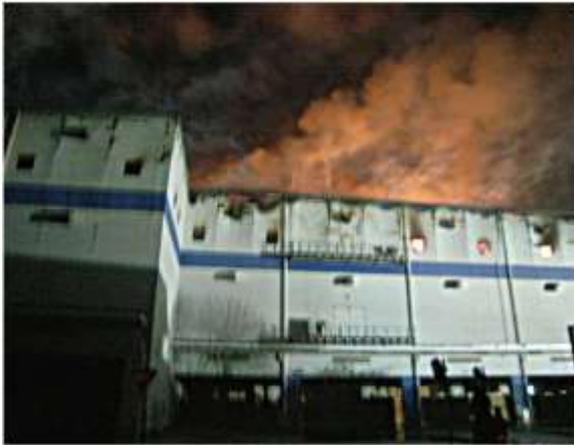
Fire spread on the west side

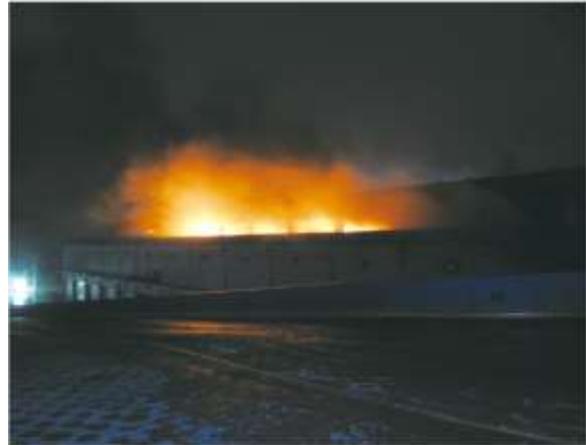
Fire spread on the east side

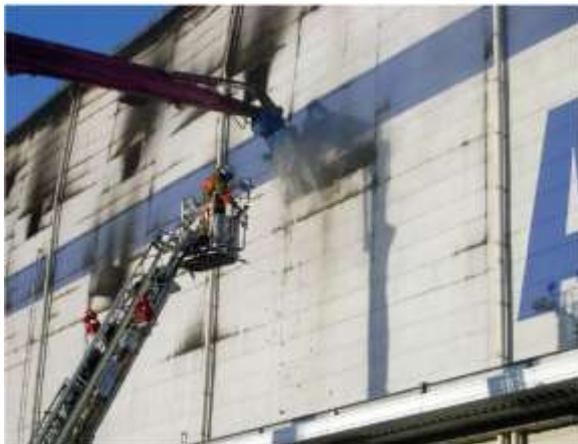
Setting the openings

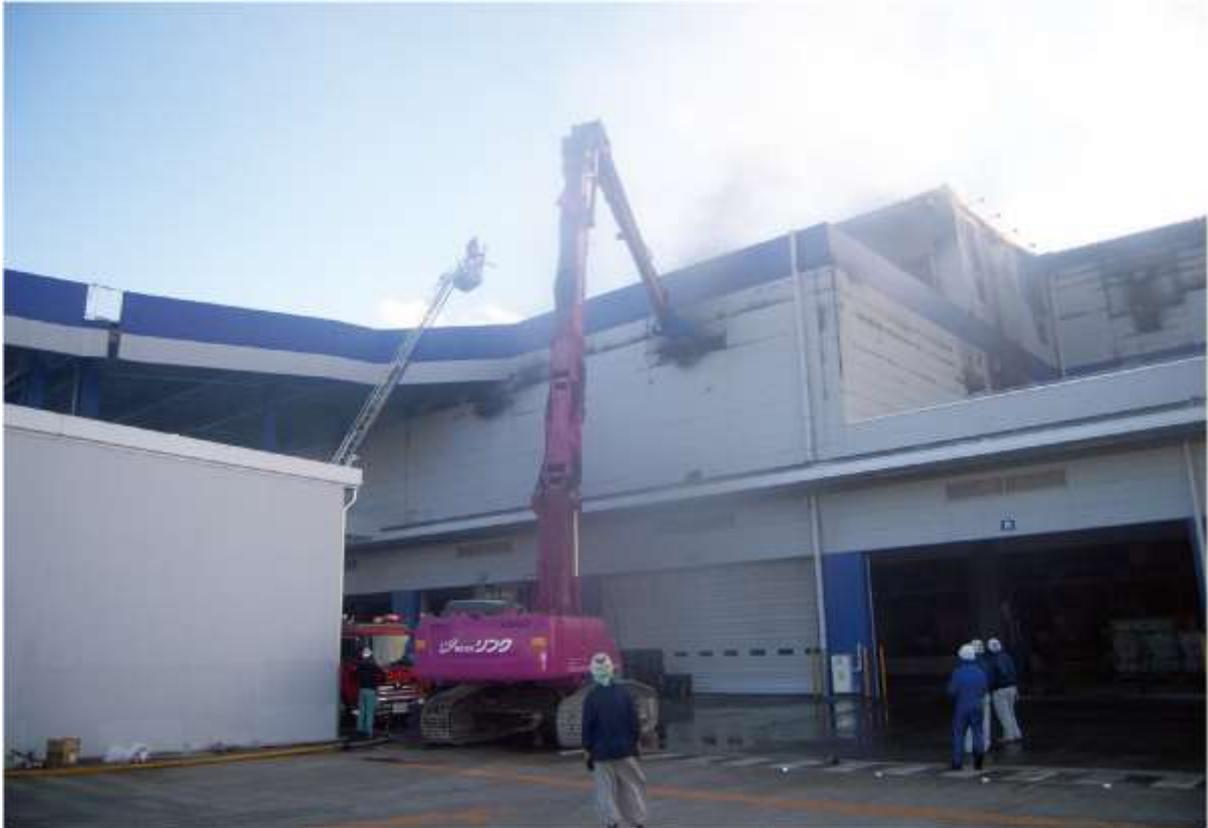
Demolishing an opening

In the case of the warehouse fire in Miyoshi Town, an exterior wall of the warehouse was demolished using heavy machinery from private companies which allowed effective firefighting. As this case indicates, in each fire department, it is also requested to close contracts for demolishing activities and water replenishing activities with local construction companies or other parties.
